**CONNECTICUT RIVER BASIN
GARDNER , MASSACHUSETTS**

**PERLEY BROOK RESERVOIR DAM
MA 00119**

PHASE I INSPECTION REPORT NATIONAL DAM INSPECTION PROGRAM

JUNE 1980

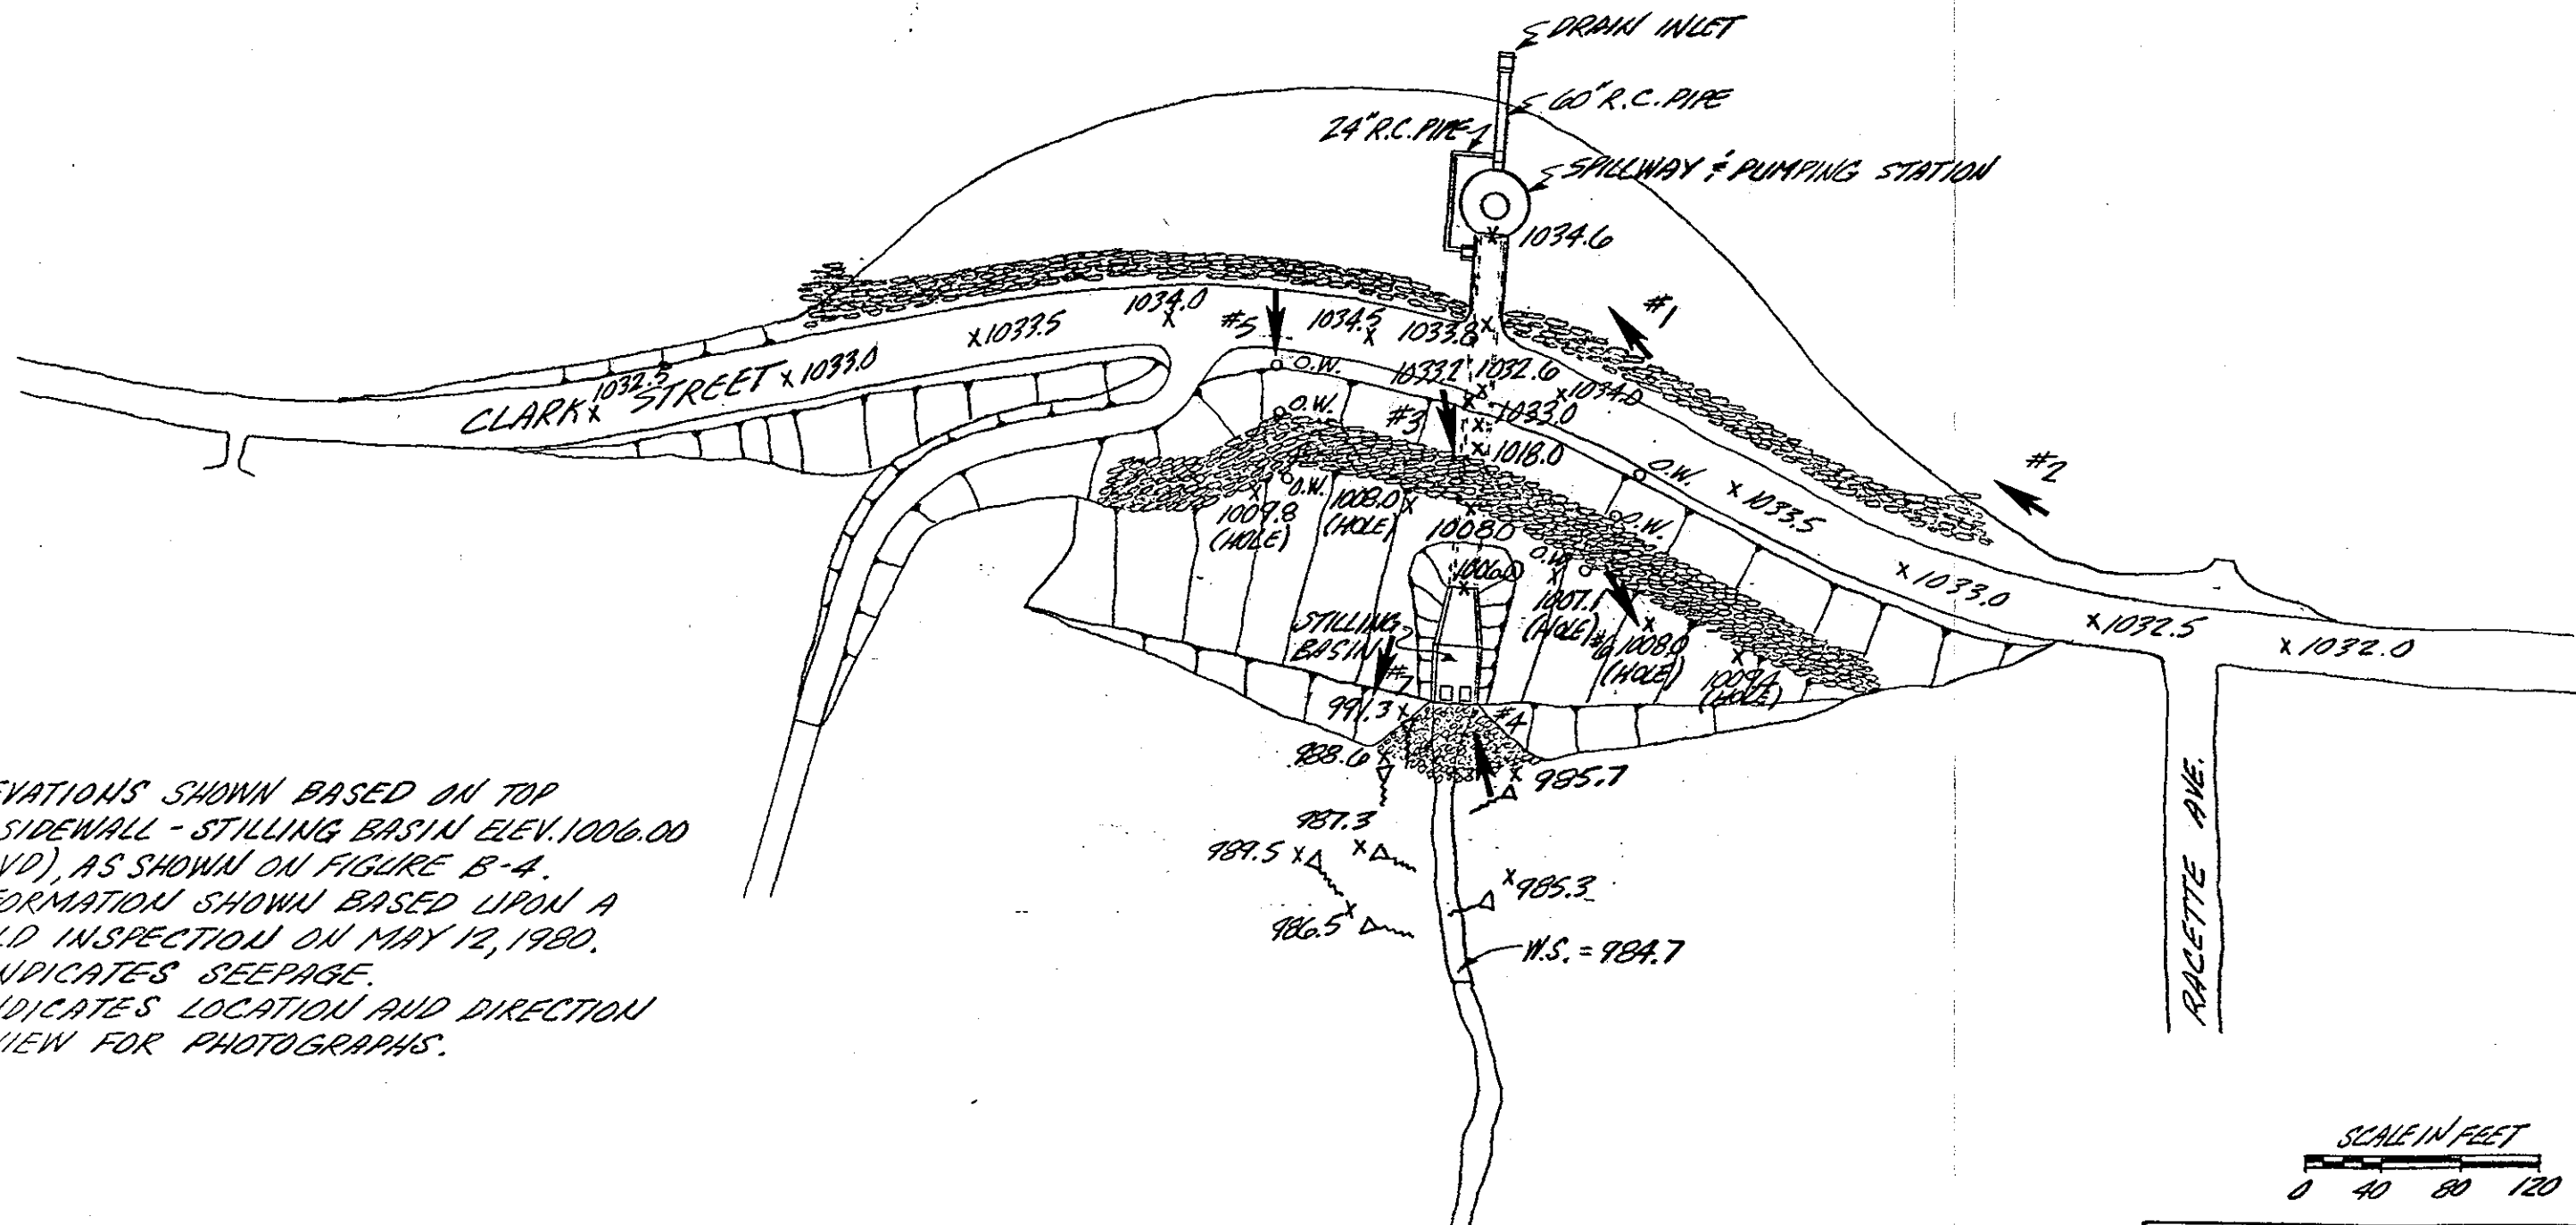
ELEVATIONS SHOWN BASED ON TOP
OF SIDEWALL - STILLING BASIN ELEV. 1006.00
(NGVD), AS SHOWN ON FIGURE B-4.
INFORMATION SHOWN BASED UPON A
FIELD INSPECTION ON MAY 12, 1980.
△ INDICATES SEEPAGE.
▲ INDICATES LOCATION AND DIRECTION
OF VIEW FOR PHOTOGRAPHS.

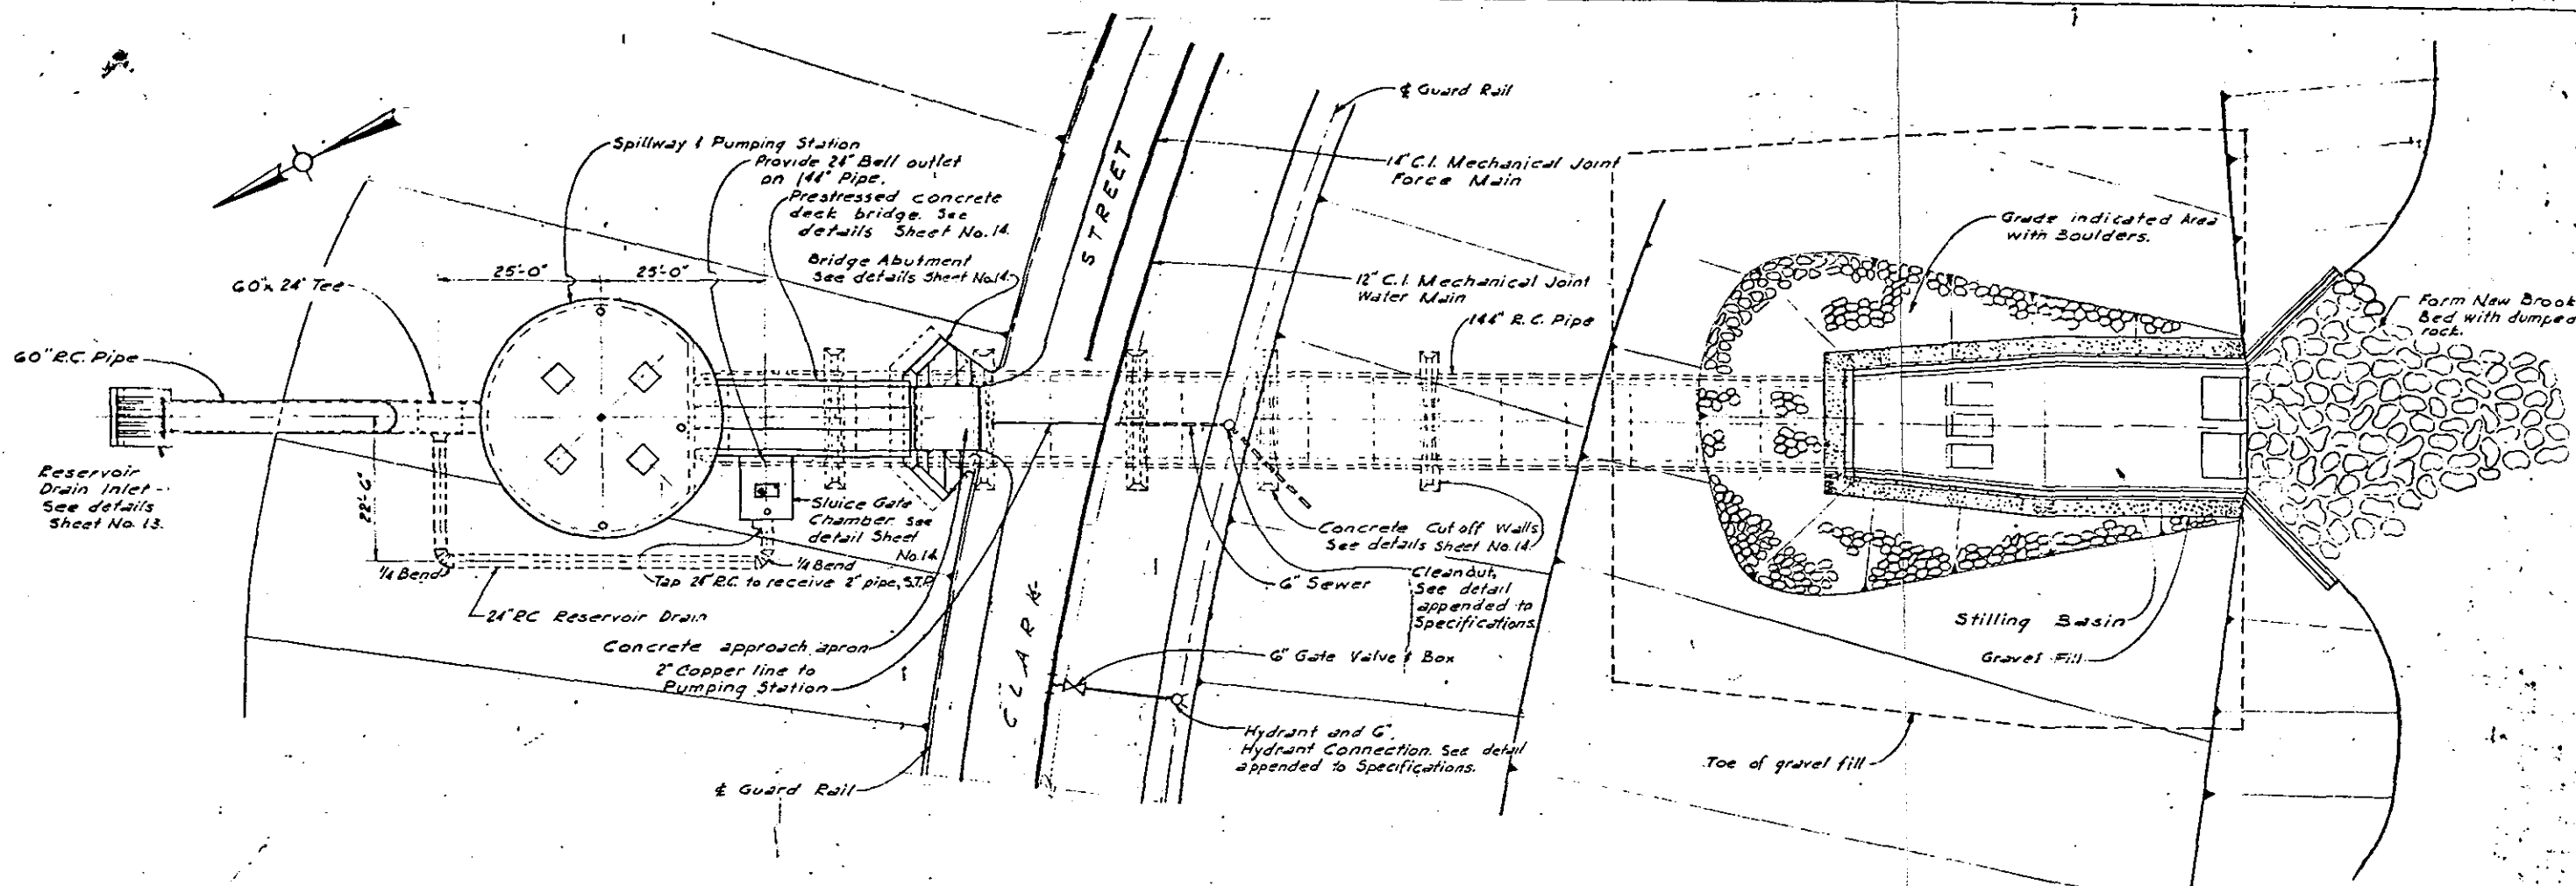
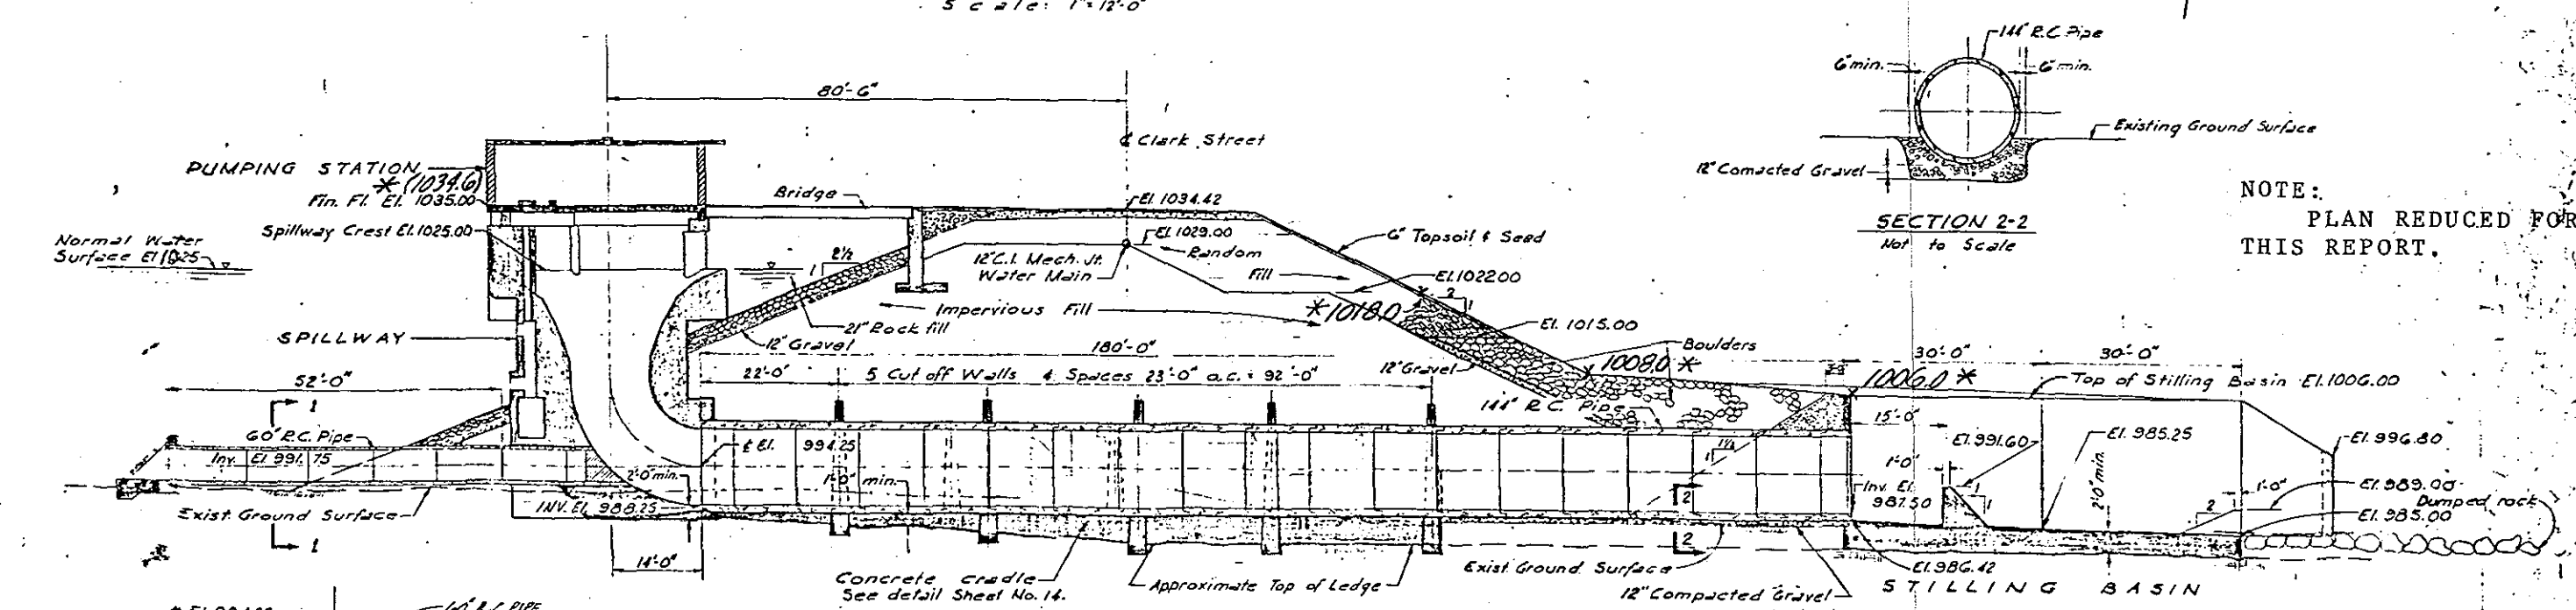
FIGURE B-3

- NOTE:
- *Elevations verified in field on 12 May '80, and based on an assumed benchmark elevation 1006.0 (NGVD) at top of stilling basin.
